Coal Mine Fatal Accident 2007-09

Operator:	CAM Mining, LLC
Mine:	Three Mile Mine #1
Accident Date:	July 16, 2007
Classification:	Surface Explosives and Breaking Agent
Location:	Dist. 6, Pike County, Kentucky
Mine Type:	Surface Coal Mine
Employment:	45
Production:	≈ 60,000 clean tons/month

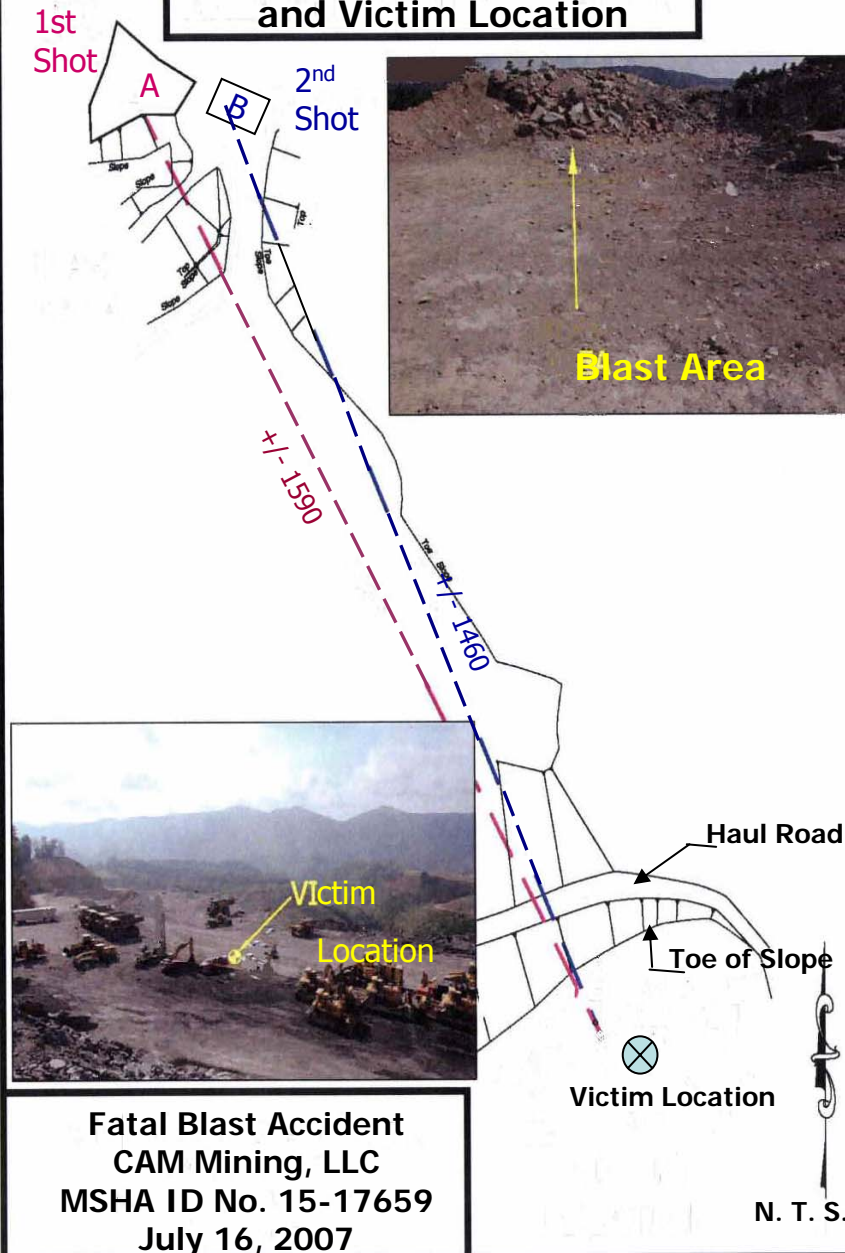
Plan View of Blast Area and Victim Location

At approximately 4:35 p.m. on July 16, 2007, a 40-year old mechanic received fatal injuries when he was struck by fly rock from a production blast. The victim had 20 years of mining experience, 10 years of which was at this mine. The fly rock that struck the victim traveled approximately 1,500 feet, into an area where miners parked their personal vehicles and mine equipment between shifts. The fly rock passed over a 50 foot embankment prior to reaching the accident site. Although several pieces of fly rock were found at the accident site, the size of the rock that struck the victim could not be determined. The accident occurred because safe procedures for conducting blasting operations were not followed.

Root Cause: The mine operator did not maintain safe control of the mining pit. Fly rock from the mining pit traveled more than 1500 feet to a staging area where equipment was being fueled and routine service was being performed. No procedure was in place to demarcate the 'Blast Site' from other production areas during the load-out crews overburden removal procedures. This increased the probability that the highwall would be 'Over Dug,' reducing the burden from its original thickness. The type of fly rock that occurred at this site was the result of insufficient burden at the opening of the blast #1 (the first blast holes that were detonated.)

Corrective actions: The mine operator developed and implemented a plan to prevent a similar occurrence of this accident. The plan includes a revision to the ground control plan that requires that the drillers log the blast holes as they are drilled and provide this log to the blaster who will include this log with the blast report. The revision also requires that adequate burden along the edge and free face of the blast site equal to or greater than 25 times the hole diameter (measured in inches) divided by twelve and that the burden along the edges of the blast site will be measured with a burden pole. The plan also requires training to be provided to the employees on the revised ground control plan and hazards associated with blasting operations.
